TITLE: The Inadequacy of Safe-Life Prediction: Aero-Engine Fan and Compressor Disk Cracking

## **The Inadequacy of Safe-Life Prediction: Aero-Engine Fan and Compressor Disk Cracking**

**B.J. Wicks, R.A. Antoniou, S.L. Slater and J. Hou**

Aeronautical and Maritime Research Laboratory

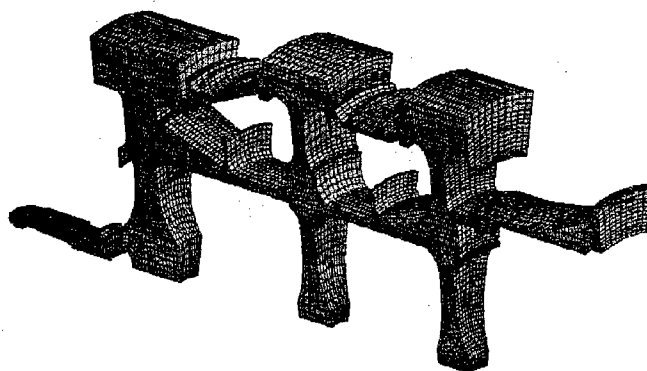
Figure 3: 3D FE model of the assembly.

A 3D cyclic FE assembly model (22.5° sector) was created, consisting of three fan disks, spacers and air seals to determine the global behaviour, as shown in Figure. 3. These components were meshed using 20-noded brick elements. The applied loading includes the centrifugal and thermal loads at maximum power setting (1, 2) Appropriate boundary conditions were applied to the end surfaces of the assembly model. Stress analysis was carried out using ABAQUS software (3) and displacement solutions were obtained.
